Important Safety Notice

SUBJECT: Cub Cadet PRO Z 500 (Z5 152) and PRO Z 700 (Z7 183) sold in Great Britain: Corrective Action and Instructions to Stop Use

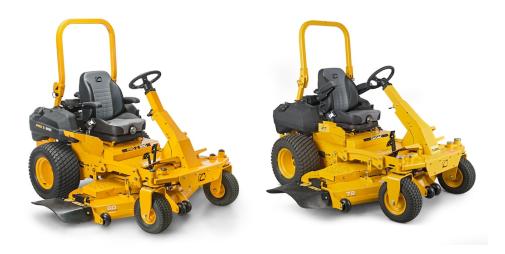
We are contacting you because our records indicate that you may have purchased a Cub Cadet PRO Z 500 (Z5 152) or PRO Z 700 (Z7 183) lawnmower. A representative image of the product is below.

Kawasaki Motors Corp., U.S.A. has determined that a product safety hazard may exist with the KM-21066-0785 voltage regulator on the Kawasaki engine fitted to your lawnmower. This may result in a fire with a potential for serious personal injury or property damage. To ensure your safety, the negative battery cable must be disconnected and secured away from the negative battery terminal.

Instructions for how to do this are included below. If you feel uncomfortable disconnecting the battery, please immediately contact your dealer to make arrangements to have the dealer disconnect the battery for you. Your dealer will disconnect the battery at no charge to you.
- 2. **Contact your dealer to arrange a repair.** The repair will involve replacement of the affected voltage regulator.

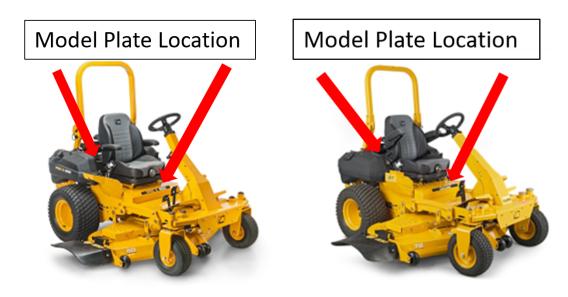
The model number and date of manufacture is printed on the identification plate visible in front of or behind the seat. The model number will appear in the upper left-hand corner of the label under the heading "Model Number". The month and year of manufacture will appear in the center of the label under the heading "DOM". See the images below for the plate location.

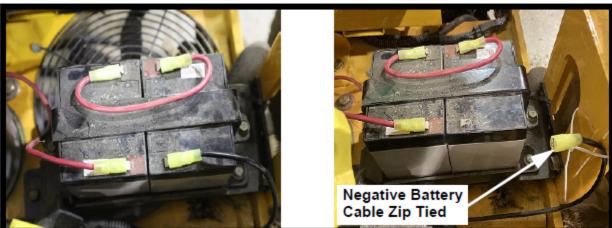
PRO-Z 500, 700, 900 Model Negative Battery Cable Disconnect

3. Next, secure the negative battery cable with a zip-tie away from the terminal as shown below.

- 1. Locate the battery and the black negative battery cable.
- 2. Remove the bolt and nut securing the negative battery cable to the negative battery terminal using the appropriate size wrenches.

Note: Take care not to touch the positive battery terminal with the wrenches, to prevent severe arcing and possible damage to the battery and or possible personal injury.
